NASA Technical Memorandum 106023

100-kW Class Applied-Field MPD Thruster Component Wear

Prepared for the
Tenth Symposium on Space Nuclear Power and Propulsion
sponsored by the University of New Mexico
Albuquerque, New Mexico, January 10–14, 1993

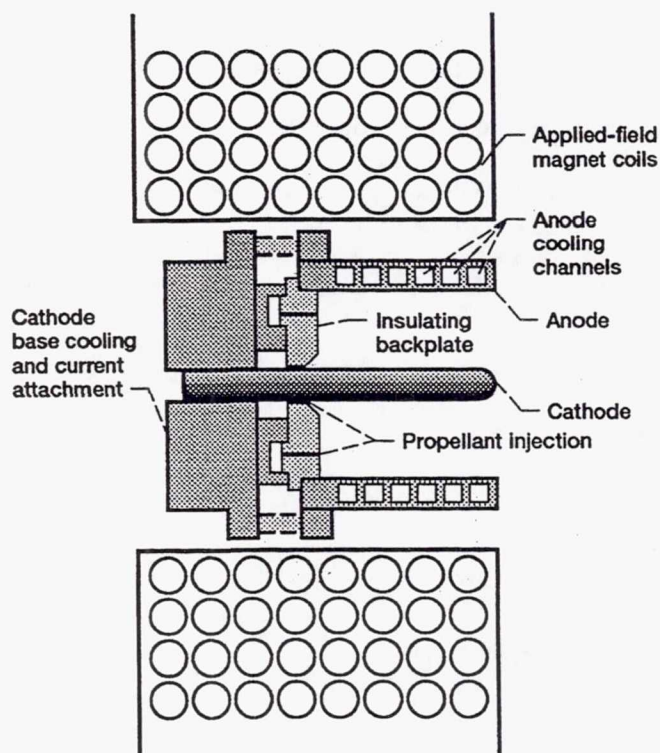
Figure 1.—MPD thruster schematic.

A schematic of a typical MPD thruster is shown in Figure 1. Propellant was injected into the thruster through the boron nitride backplate using an annulus at the cathode base and twenty-four equally spaced 0.16 cm diameter holes at the mid-radius between the cathode and anode. Most of the thrusters had 0.64 cm radius, 7.6 cm long, 2% thoriated tungsten rod cathodes, though other radii and lengths were also tested. In addition to the 2% thoriated material, two impregnated tungsten cathodes were tested. The first was a 0.64 cm radius, 7.6 cm long rod, the second was a hollow cathode with an outside radius of 1.5 cm, an inner radius of 1.0 cm, and a length of 6 cm. The hollow cathode is shown in Figure 2. The anodes were 2.54 cm, 3.81 cm, and 5.1 cm in radius and 7.6 cm and 15 cm long. All anodes were water-cooled copper.

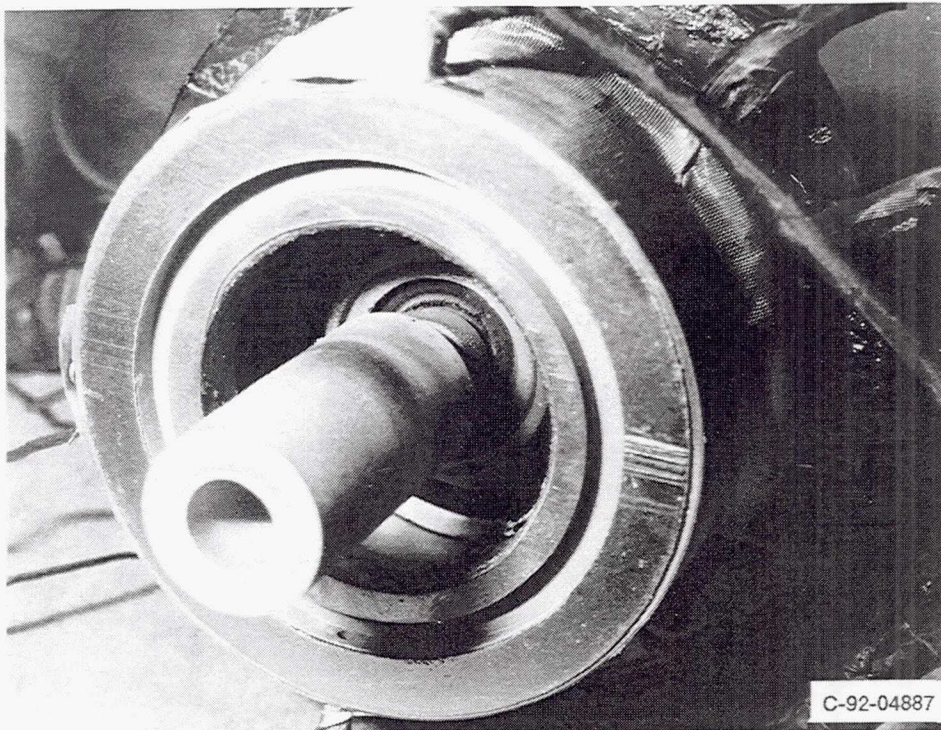
Figure 2.—Hollow cathode thruster without anode.

The principal advantage of the hollow cathode geometry appears to be a reduced depletion rate of the low work function impregnated mix via a reduced operating temperature and increased material redeposition rate. The barium impregnated hollow cathodes have been tested in MPD thrusters by Mantenieks and Myers (1991). The measured erosion rate of the hollow cathode in our test was about three times lower than that of the rod cathode made of the same material. Analyses of material deposited inside the thruster indicate that most of the mass lost from the hollow cathode was barium. At the deposition sites, the ratio of barium to tungsten by weight was 6.7. This again shows that simple mass loss measurements of cathodes can be misleading, because the high barium loss rate will likely lead to a runaway increase in material work function. Improved hollow cathode designs are essential to provide sufficiently low operating temperatures and high emission site pressures for adequate cathode lifetime.

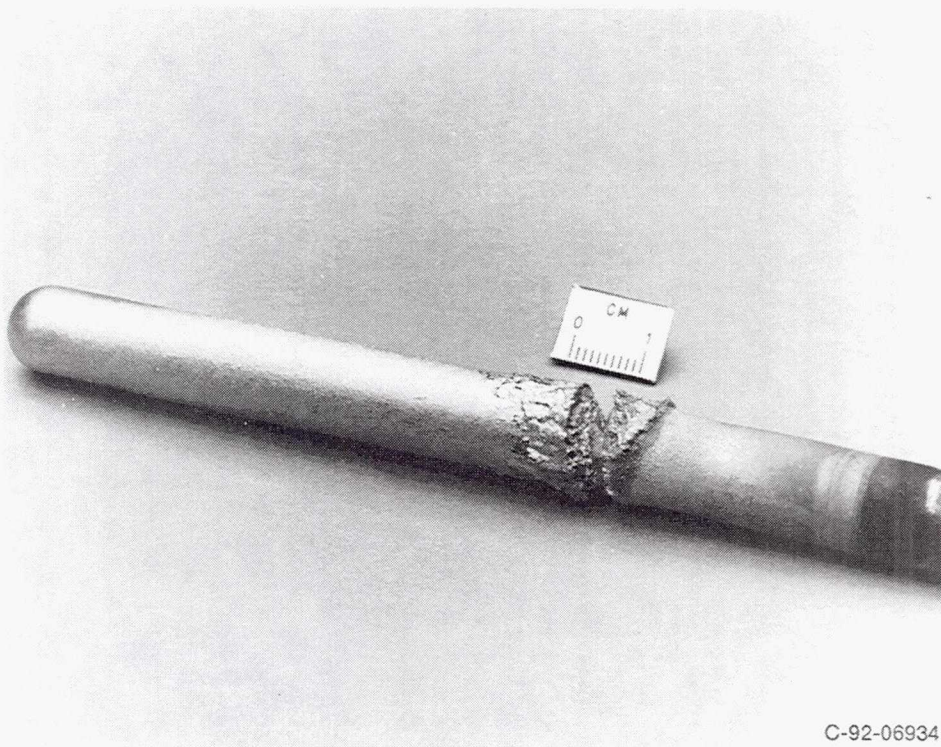
The erosion rate decreased after "high purity" argon (99.995%) was replaced by "high purity research" grade argon (99.999%) in our tests. However, the measured cathode erosion rates still varied from 0.038 $\mu\text{g/C}$ to 0.57 $\mu\text{g/C}$ from test to test, and the groove type erosion still occurred occasionally. It was not until a procedure of vacuum purging the propellant lines before every test was initiated that the groove erosion was not observed. The impact of oxygen and water vapor on the erosion rate of thoriated tungsten rod cathodes has been discussed previously by Polk et al (1990) where he pointed out that at cathode temperatures above 1200-1300 °C, tungsten oxides volatilize faster than they are formed, so that the limiting rate process is the flux of oxygen and water to the surface. Auweter-Kurtz et al. (1990) also reported significant cathode erosion rate reductions by replacing welding argon with high purity argon (99.998%) and the addition of drying deoxygenation device in the propellant line. The very large contaminant density, contaminant temperature, and cathode surface temperature gradients at the cathode base which result from the high current concentration in that region may yield the observed highly-localized erosion distribution.

Figure 3.—"Groove" erosion in 2% thoria tungsten.

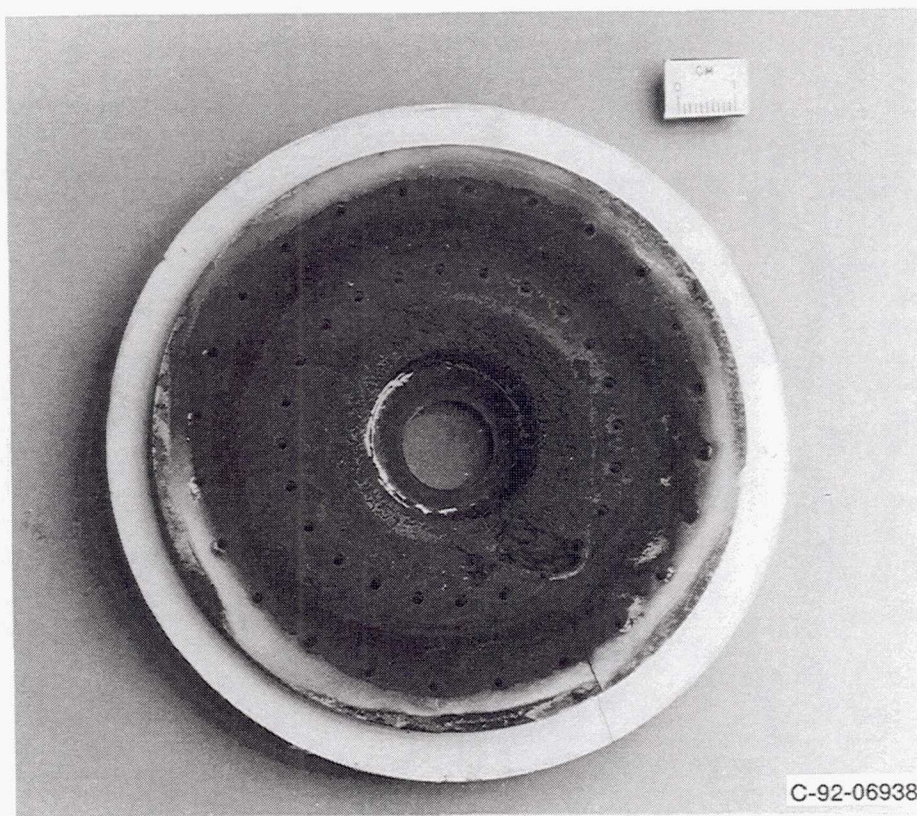
Two failure mechanisms were observed with the boron nitride insulators. The first was erosion at the annulus of the cathode base. It was found that the insulator eroded away from the downstream face, gradually forming an expansion cone. An example of this kind of damage is shown in Figure 4. While erosion was rapid with new insulators, the erosion rate appeared to decrease with time as the surface receded from the hot cathode. It was found that the insulator mass loss could be reduced by starting with a flared annulus and increasing the gap between the insulator and the cathode.

There are two potential causes of the boron nitride erosion. The first is that tungsten evaporated from the cathode is deposited on the boron nitride and forms a BN-W eutectic (Jahn 1968 and Rieck 1967). Most tungsten borides and nitrides have melting temperatures below 2000 °C, which could explain the high material loss rate. The second potential cause is the presence of oxygen or water vapor in the propellant. While boron nitride can be used in an inert and reducing atmospheres up to 2800 °C, in oxidizing atmospheres the maximum operating temperature may drop as low as 985 °C (Sohio 1984). While not quantified, based on visual inspection the boron nitride erosion rate appeared to decrease following initiation of the vacuum purge procedure described above.

Figure 4.—Degradation of boron nitride insulator.

Boron nitride insulator erosion was reduced by both the improvement in propellant purity and increasing the cathode - insulator gap. Cracking of the insulator was also reduced, but not entirely eliminated. Deposition of cathode and anode material found on the downstream side of the insulator tested may result in insulator failure for extended tests.

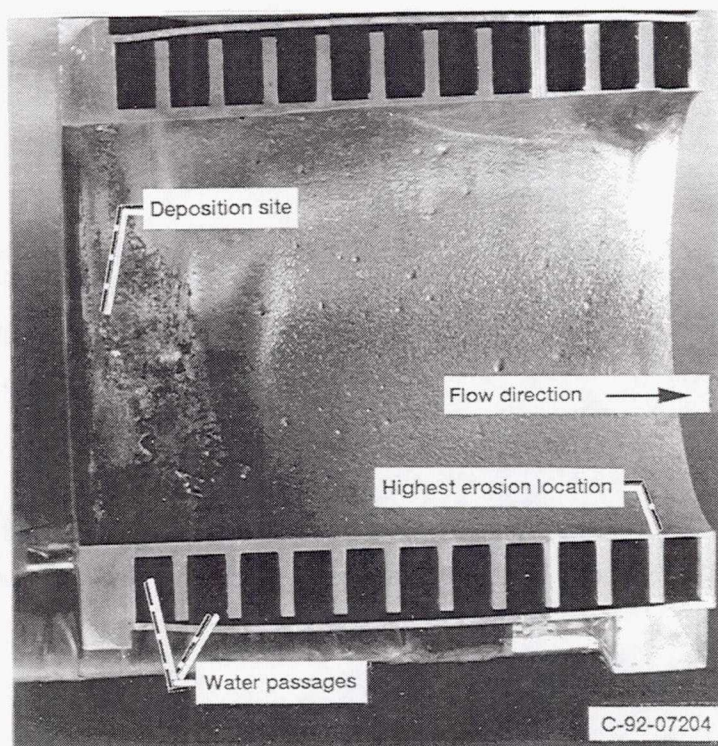
The anode was sectioned to measure the erosion of the anode surface. The anode cross-section is shown in Figure 5. It is evident that the surface erosion increased toward the exit plane. A maximum erosion rate of 0.1 mm/hr was measured at the downstream lip of the anode surface. To the best of our knowledge, this is the first observation of this erosion mechanism in a MPD thruster.

Similar surface texturing has been observed in materials processing experiments for sputtered materials under energy argon bombardment (Kaminsky 1965 and Behrish 1981) indicating that atom or ion sputtering may be the cause of the erosion. Assuming a uniform radial velocity profile, for the estimated specific impulse of approximately 1500 s, the argon atom energy should reach up to 50 eV, which is high enough for argon ions to overcome the estimated anode voltage drop of approximately 20 V and impact the anode surface with an energy of approximately 30 eV. This is over the 25 eV sputtering threshold energy for copper sputtering by argon. If charge-exchange collisions take place near the anode surface, neutral atoms may hit the anode with the full 50 eV energy. The copper sputter yield for perpendicular impingement is approximately 0.05 atoms/ion at 30 eV incident energy, and this increases to 0.2 atoms/ion at 50 eV (Behrish 1981). At non-normal incidence, the sputter yield of energetic argon ions on copper may increase by a factor of two (Kaminsky 1965). While attempts were made to estimate the erosion rate due to sputtering, it was not possible given the uncertainties in angle of incidence of the incoming particles, incident energies, and incident particle fluxes.

Figure 5.—Cross section view of sputter-eroded water-cooled anode.

The sputtering erosion mechanism clearly only becomes an issue when the propellant energy exceeds the sputter threshold for the anode material. Given that metal sputter yields at the same energy level do not vary by more than an order of magnitude, it will not be possible to eliminate the sputter mass loss by using alternative anode

materials. Thus, the solution to this problem is to choose a light propellant which has an extremely low sputter yield at energies of tens of electron volts. Propellants such as hydrogen, deuterium, and lithium, satisfy this requirement for the exhaust particle velocities required for missions of interest (Gilland et al. 1990 and Hack et al. 1991).
